¹Olanrewaju Afolabi Layiwola*, Thaddeus Chidiebere Nwaoha, Jasper Ahamuefula Agbakwuru and ²Ezenwa Alfred Ogbonnaya

In this paper, an analysis of various components of ship submersible pumps such as impeller, motor, mechanical seals, thrust bearing, electrical cable, housing, shaft, pressure sensing instrument and variable speed drive are carried out. Marine submersible pump related accidents and various causes of failure of the submersible pump mechanical seals are discussed, including pump vibration, dry running of the pump, temperature (higher), unsuitable start up procedures and wear and tear in maritime environment. Also, regulations governing safety of machineries onboard vessels are discussed.

Insights into Causes of Failure of Submersible Pump, Maritime Accidents and Onboard Regulations

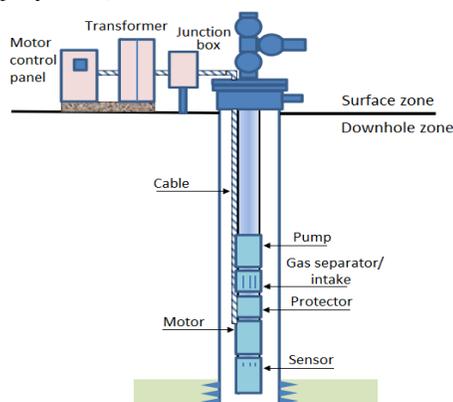
Submersible pump on semi-submersible ship is powered by electric supply from a transformer or a switch board. The system is made up of a centrifugal pump, control mechanism, cable, seal, gas separator and a motor that drives the pump as shown in Figure 1. The fluid flows from the well through the strainer, the motor and passing through the gas separator and up to the pump before discharging. It provides a cost-effective and successful ways of lifting large volume of fluids at a higher flow rate during operation. Submersible pump is resistant to corrosion and can operate in a very harsh environment and have a wider flow rate. The system is sensitive to gas and sand contained in the fluid to be pumped, which can cause serious damage to the pump (Baker Hughes Centrilift, 2008; Canadian Oilwell System Company, 2010).

Figure 1: Electrical submersible pump (Fonseca et al., 2019)

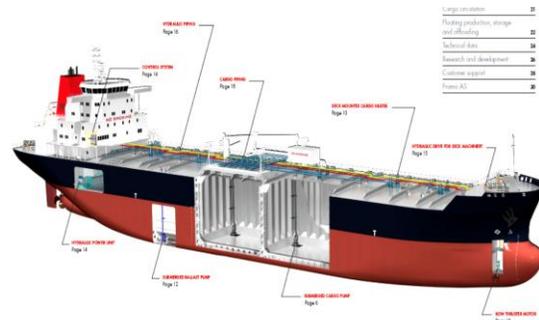
These pumps are designed to handle different types of fluid depending on the type of materials being used for its manufacture. Most of the marine pump are self-priming and are positioned vertically with the motor at the top position (KSB, 2020). The marine bilge pump can either be centrifugal, diaphragm, reciprocating or flexible impeller pump. The centrifugal submersible pumps are used in both large and small vessels for the discharge of accumulated water in the bilge tank overboard. The submersible pump used onboard can be a life saver in case of flooding by waves especially if the hull of the ship is holed. The pump is capable of removing the water effectively to allow for the repair of the damaged hull section of the ship to prevent the ship from sinking (Caver pump, 2020). Submersible pumps used on cargo vessels are centrifugal pump driven by hydraulic motor for efficient operation as shown in Figure 2. This submersible pump is used to pump different types of liquid cargo without regards to the liquid viscous nature. This submersible pump is made up of stainless steel with smooth surface for easy cleaning. The pump is positioned vertically and it is of a single stage design. The pump seal can be monitored by removing the cofferdam from the plate top of the pump during the inspection process of the seal for damage (Framo, 2022a).

Figure 2: Submersible pump in cargo vessel (Framo, 2022a)

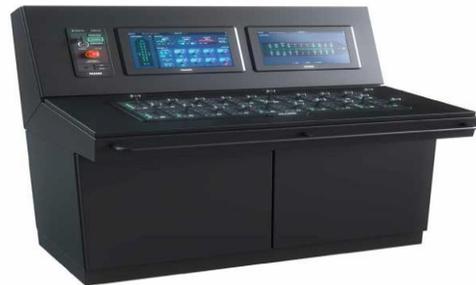
These submersible pumps are powered by either hydraulic or electric units depending on the manufacturer and they are operated from a remote position in the wheelhouse and /or cargo control room as shown in Figure 3. This type of submersible pump controls allows for quick loading and unloading of bulk liquid cargo. It improves the performance of the cargo handling process and also enhance efficient and safe discharge of liquid cargo from the vessel. This pump aids the ballasting and de-ballasting process of the vessel for her effective stability (Framo, 2022b).

Figure 3: Hydraulic power unit (Framo, 2022a)

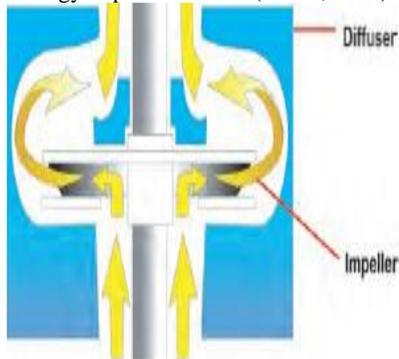
Impeller: The impeller is the solid rotating component of a pump in the form of curved blades arranged on a central hub that transfer energy from the motor to the fluid causing the fluid to flow and gather pressure. It is shown in Figure 4. The function of the pump is to produce the needed centrifugal forces after it has been subjected to pressure, making the impeller to rotate at a higher speed for the movement of the fluid up through the discharge pipe. In the process, the

kinetic energy in the diffuser is lost in other to convert this rotational energy to pressure force (Gabor, 2009).

Figure 4: Submersible pump impeller (Gabor, 2009)

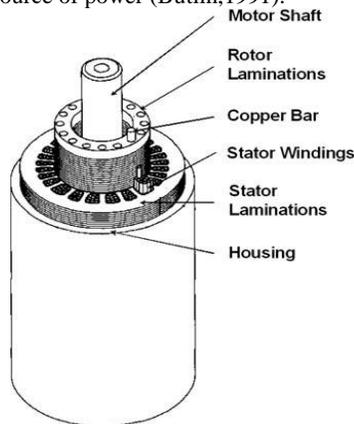
Motor: The types of motor used in the design of some submersible pumps are of two-pole three phase induction type as shown in Figure 5. The process of operation of this motor is by electromagnetic induction in which the magnetic field is created in the stator and one of the coils is contained at each phase on the standing part of the motor. The rotation of the motor produces a field which is caused by the change of direction of the alternating current being produce. The speed of the motor depends greatly on the frequency of the alternating current and also the number of stator poles. A shaft is attached to the motor which serves as the rotor. The rotor is design as a squirrel cage of copper bar which is not coupled to the source of power (Butlin,1991).

Figure 5: Submersible pump motor (Gabor, 2009)

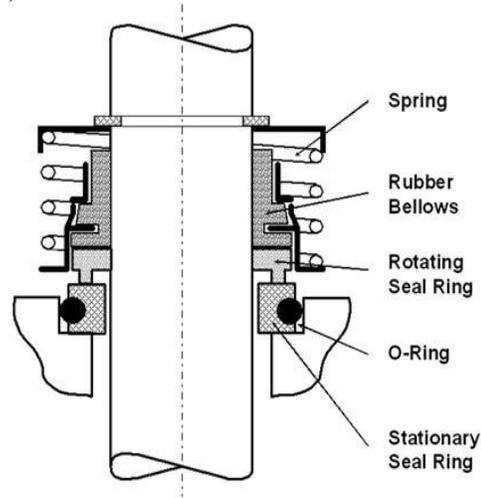
Seal: The seal installed between the motor and the pump is referred to as a protector, this seal protects the motor from water (fluid) ingress. It is mounted on motor shaft and comprises of stationary ring and rotating rings on which rubber bellow and springs are mounted. It is prevented from playing around on the shaft by a circlip. The ingress of this fluid into the motor section will be dangerous for the continuous running of the submersible pump. The motor of a submersible pump is filled with electric strength oil and when the motor is operating at a high temperature, the housing (casing) of the pump will burst if the housing is completely sealed. This is as a result of the development of pressure inside the housing due to the oil expansion. In this way, the only components having protective seal are the

pump and the motor sections as shown in Figure 6 (Swatek, 1997).

Figure 6: Submersible pump seal arrangement (Gabor, 2009)

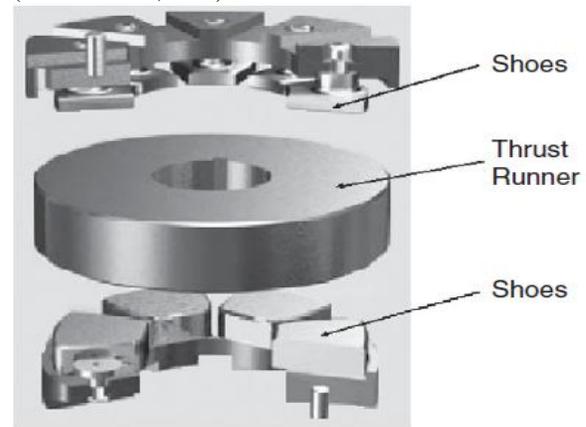
Thrust bearing: The axial forces being developed during the operation of the submersible pump are absorbed by the thrust bearing. It comprises of the finely finished circular ring called thrust runner and the thrust shoes on either sides. The thrust bearing is installed in the units containing the seal (protector), it is used to reduce the bulk of the thrust forces that is developed from the operation of the motor. Submersible pump uses pad-type plane bearings because of the reduced heat produced during its operation. The bearing supports higher loads and can operate with lubricating oil having contaminants in it. The load carrying capacity of this bearing relies greatly on the fluid film. The fluid film protects the metal-to-metal contact of the stationary and moving parts of the thrust bearing as shown in Figure 7 (Zeidan & Jain, 2000).

Figure 7: Submersible pump thrust bearing (Gabor, 2009)

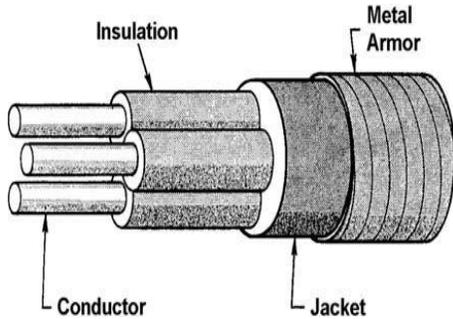
Cable: Submersible pump cable is of three phases, it is used for the transmission of electricity to the motor, from the power source to the motor connection as shown in Figure 8. The submersible pump operates under a very severe

environment and the following requirements needs to be met for the safe operation of the pump under the API regulations:

- The wire diameter must be small to allow for free passage
- Their defective properties must be maintained under severe environmental conditions (e.g. temperature, fluid & gas)
- Protected against damage
- Must be insulated to endure high temperature
- Must be resistant to oil/water
- Does not allow the migration of gases into the cable (API, 1993).

Figure 8: Submersible pump cable (Gabor, 2009)

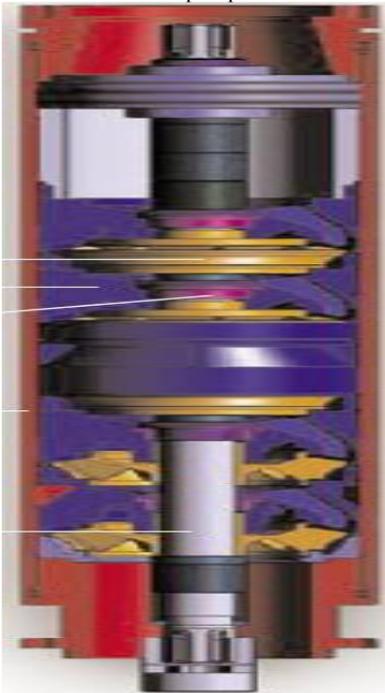
Housing: The various component of submersible pump is housed to prevent the fluid from getting access to the vital parts of the pump as shown in Figure 9. The housing is made of alloy steel grade material, the surface on the outside of housing is coated to protect it from corroding due to the corrosive nature of the fluid that is been pumped or the type of environment in which the pump is been used.

Figure 9: Submersible pump housing unit (Canadian Advanced Incorporated, 2016)

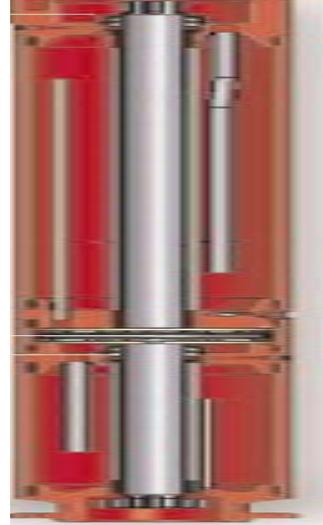
Shaft: The shaft of the submersible pump is made up of finely finished Monel k-500 material. This gives the shaft the needed strength to maintain the high torque generated from the motor as shown in Figure 10 (Canadian Advanced Incorporated, 2016).

Figure 10: Submersible pump shaft and thrust bearing arrangement (Canadian Advanced Incorporated, 2016)
